Menangle Underbridge Assessment
Appendix B
Fabrication and Structural Features

Fabrication and Structural Features

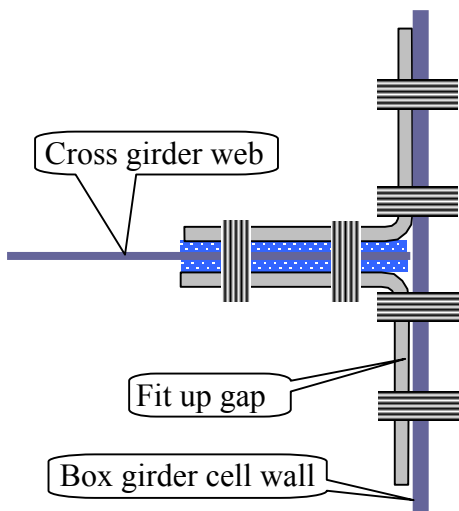
Figure B3 – Cleat attachment

The significant additional problem with this joint is the restraint offered by the part of the connection already assembled. This is illustrated in Figure B3. It is practically impossible to avoid a gap between one of the cleats and the side wall of the bottom cell. Very high flexural and tensile stresses are set up in the cleat as the rivet cools, particularly if the rivet is close to the fillet of the cleat.

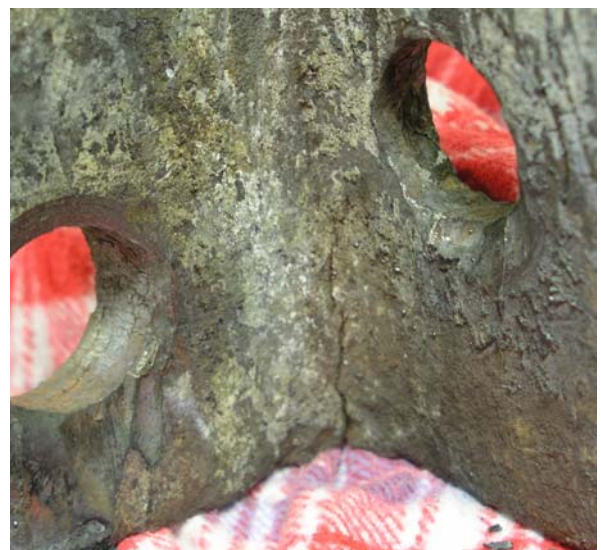
Figure B4 – Crack in cleat (S2-SG27-dn-south)

In addition, there is evidence of massive blows with the sledgehammer on the rivet, with the shock load transferred to the cleat. If this is sustained near the edge of the plate it can be sufficient to rupture the plate. Figure B4 shows the crack in the fillet of the cleat removed from the bridge for fatigue and material tests. The leg of the cleat on the right was connected to the bottom cell wall of the main box girder. The indentation of the rivet head in the plate to the right of the crack is evident. It is on an angle because of the difficulty of access. The crack is quite wide at the edge of the plate, about 1 mm, characteristic of a ductile tear rather than a fatigue crack.

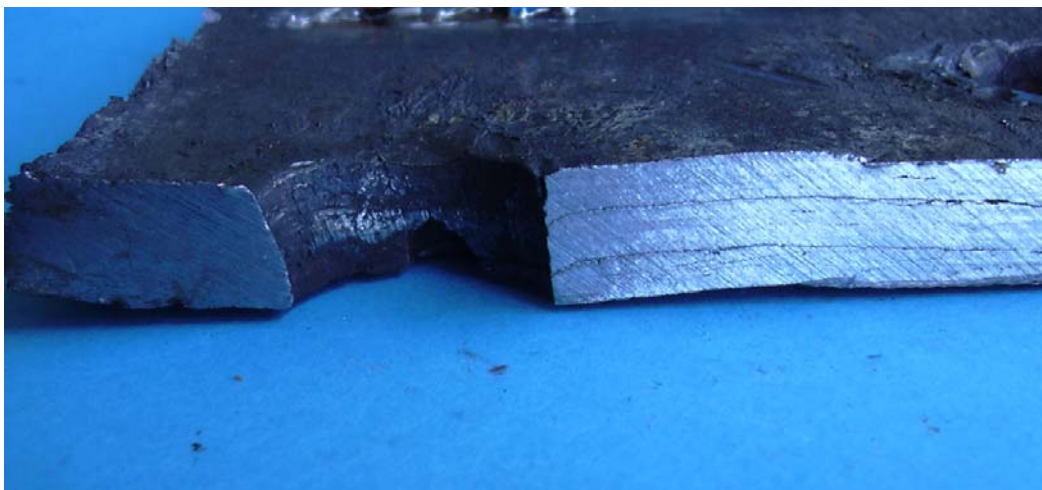
Normally riveting is performed on loose pieces which have nothing to prevent the plates clamping together snug tight together. In this case this is prevented by the cleats being riveted to the web of the cross-girder first. Moreover, if there is warp or twist of the cleats a gap can be present on both sides. An additional cause of gaps lies with the punched holes, which often have a rim of metal on the punch-out side, which is rarely fully filed away, so that a gap remains. Figure B5 shows a section through a rivet hole of the cleat removed from the bridge for laboratory testing. This picture shows the lip at the edge of the hole, and the distortion of the plate. Major laminations are also evident. The hole is not punched through at right angles.

Figure B5 – Section of cleat at punched hole showing distortion and inclination of the hole

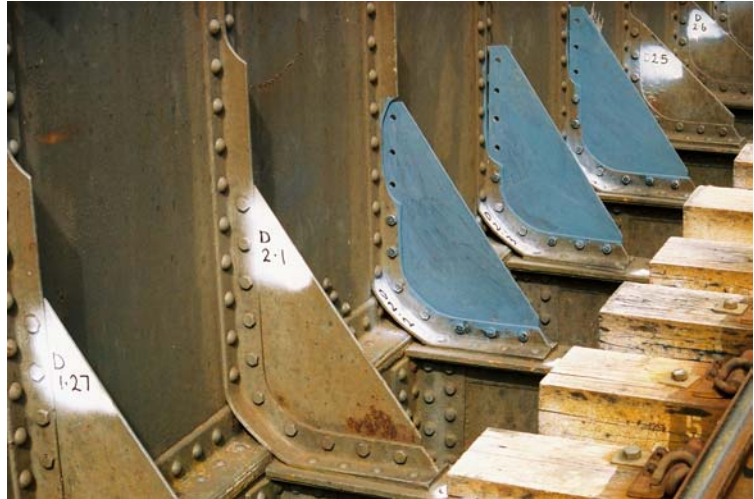
girder very close to the fillet of the flange angle – so close that driving the rivets would have been very difficult. The snaps of the rivets near the fillets in the cross girder were filed away to give access to drive the last rivets of the connection into the box girder bottom cell. This is evident in Figure B6, a feature repeated many times the cleat connections.

Figure B6 – Secondary cross girder connection to box girder, with original and replaced gussets

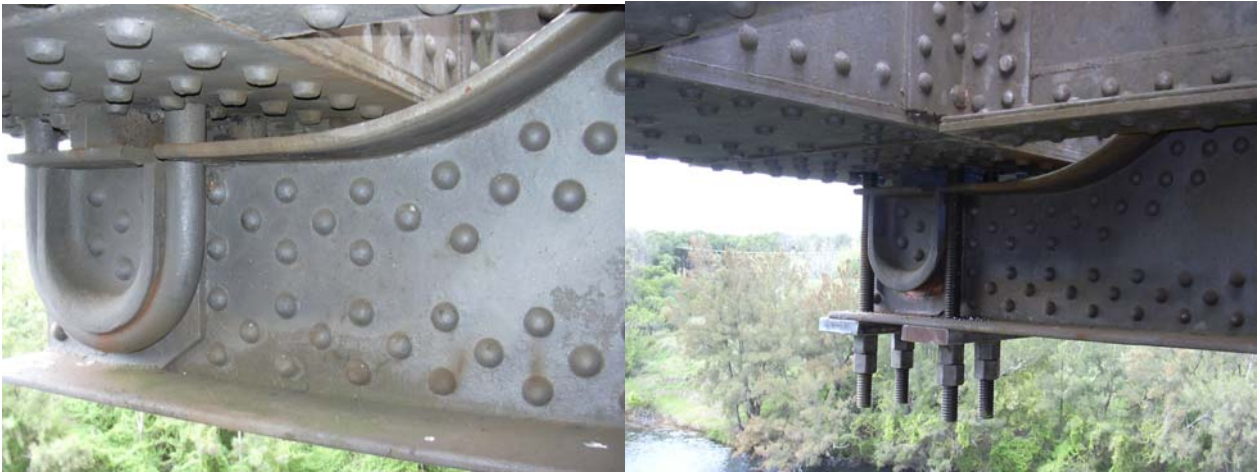
The primary cross girders were supported on U-bolts, now replaced by threaded suspension rods (Figure B8). This suspension system is virtually free to sway in the longitudinal direction so the primary cross girders resist little of the longitudinal forces. Longitudinal translation of the suspension bars imposes bending moments on them.

figure B8 – U-bolt suspension and replacement for primary cross girder

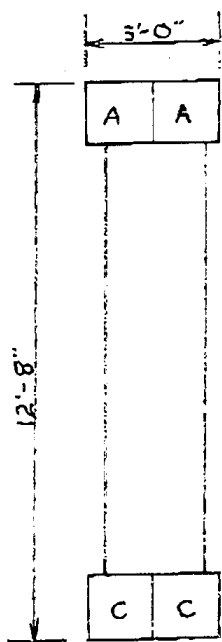
The main wrought iron girders of box section, as in attached sketch shown diagrammatically, are spaced 28'6" centre to centre. There is little paint on the spans and the tops of the girders are rusty. The web interior can be inspected with a torch and there seems to be no corrosion except near the ends. Chord AA could be inspected with difficulty and CC not at all; there is some corrosion of the chords visible near the ends but the remainder is probably sound. It is to be noted that the plates are in places ¼" thick.
