# GAZETTE

Australasian Institute of Engineer Surveyors Inc.

November 2004

## Boiler Operation and Maintenance

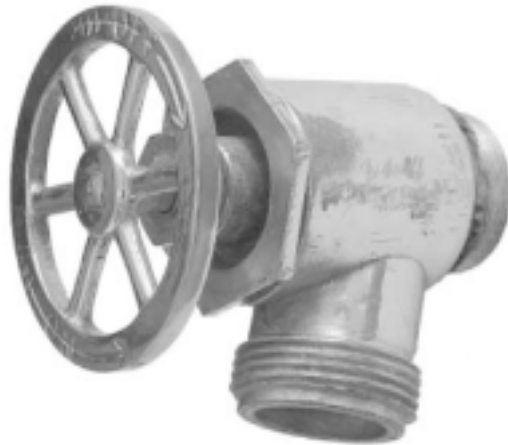
## CHROME PLATED VALVE

A service technician was injured while applying hand pressure to close a fire hydrant valve to prevent it leaking. The injury occurred when the centre of the 64 mm chrome plated brass fire hydrant valve, weighing 2.8 kg, was forced from the valve body by the water pressure in the system.

- ★ Washers in this and other fire hydrant valves were replaced two days earlier and were correctly re-assembled.
- ★ The failed valve body appeared to be soft and distorted easily.
- ★ The valve was approx 40 to 50 years old.
- ★ The technician was standing in front of the valve to close it.

- ★ Where chrome plated fire hydrant valves are installed it is strongly recommended that building owners have them inspected by a 'competent person'. They should be replaced where faulty.
- ★ Persons should not stand in front of hydrant valves during servicing, adjustment or operation.

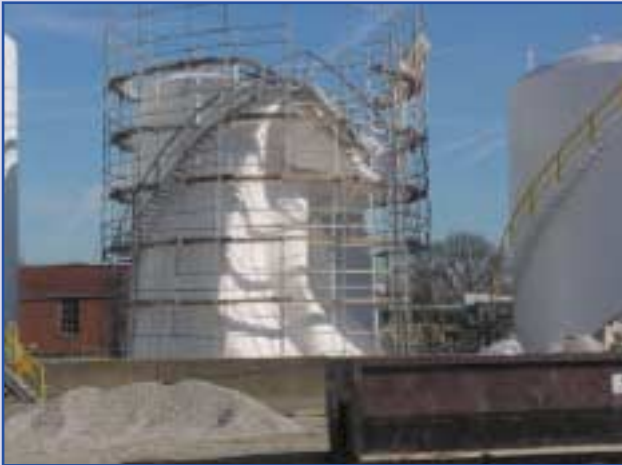
## COLLAPSED TANK

If a Tank is not designed for vacuum, odds are it will be damaged if placed under vacuum.

Low pressure storage Tanks and Railcars are particularly susceptible to damage.

This is why those low pressure switches on the suctions of blowers are so important – you can't manually shut the blower down fast enough to avoid damage if the blower pulls vacuum on a tank.

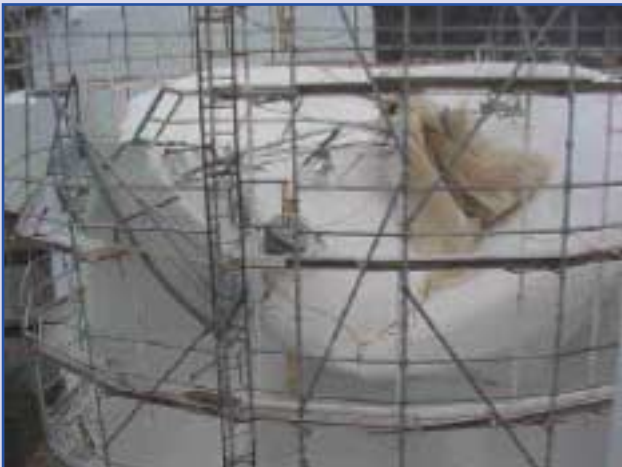
Not only is the equipment damaged but the hydrocarbon contents may also be released

This tank collapsed while being pumped out! Painters had covered the vent with plastic sheeting. The steel tank collapsed before the plastic sucked through.

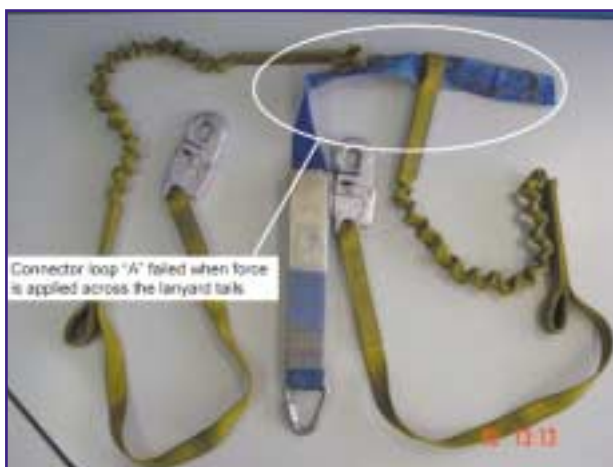
Figure 1: Twin tail fall arrest lanyard

The twin tail arrest lanyard is the term used to describe a fall arrest system where a worker uses the twin tails of the lanyard to hook on and off as he or she climbs a structure. In this method the climber is always connected to the structure via one of the tails as he or she climbs the structure. An example of a twin tail type lanyard can be seen in Figure 1.

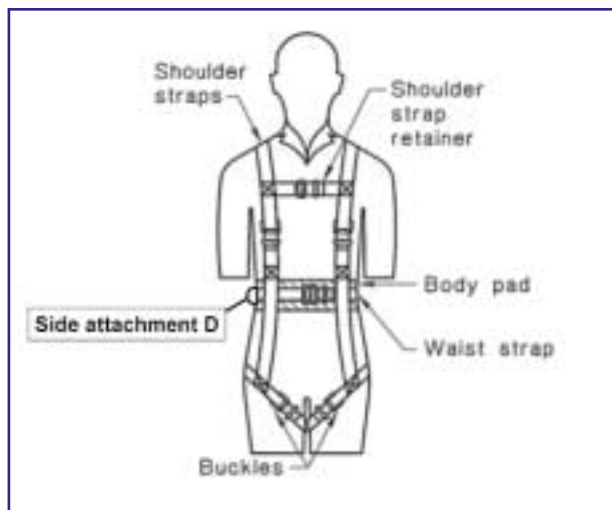
Figure 3: Example of harness showing side attachment D

The side attachment D on the harness is generally intended for the user of the harness to operate in travel restraint/work positioning mode and should not be used for attaching a fall arrest lanyard. Connection of any part of the lanyard to a side attachment D may lead to the energy absorber being by-passed in the event of a fall. The shock loading will effectively be transferred to the twin tails of the lanyard.
