Menangle Underbridge Assessment
Appendix B
Fabrication and Structural Features

Fabrication and Structural Features

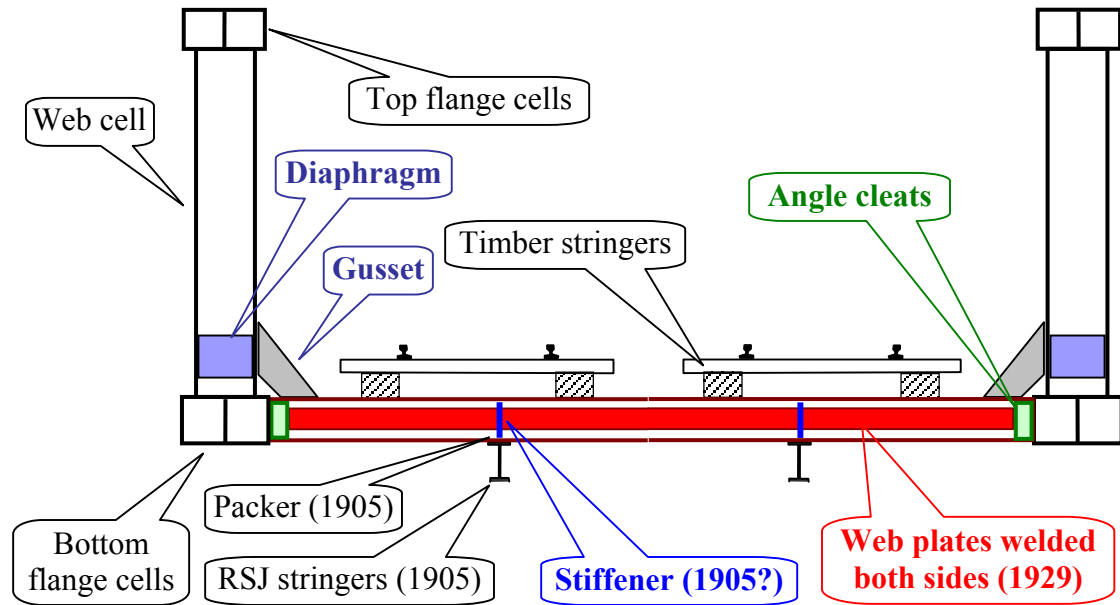
Figure B1 – Cross-section showing original cross girder with added stringer support (1905)

Figure B1 shows the cross-section as built in 1863, with the underslung stringers added ca. 1905-07. These stringers transferred some of the load from the cross-girders to additional ‘primary’ cross-girders as shown in Figure B2.

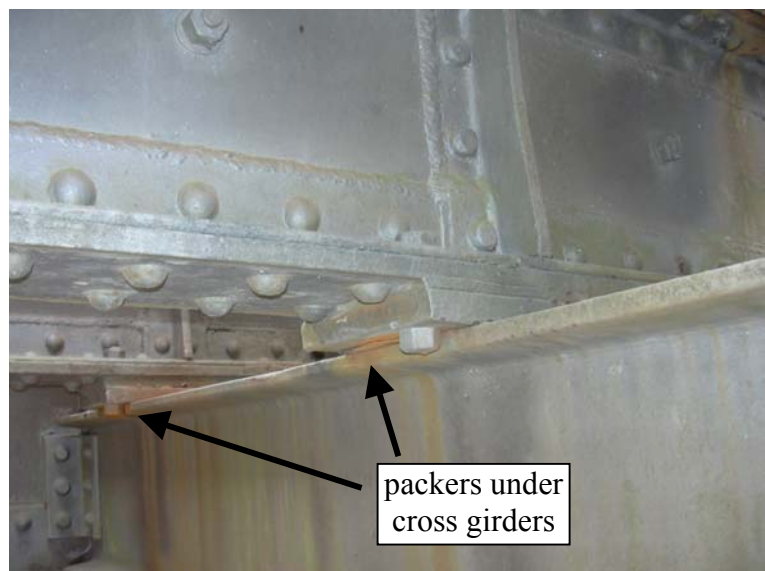
Figure B7 – Steel stringer connects to primary cross girder(left), supports secondary cross girders

The steel cross girders added in 1907 (one for three of the original cross girders) are known as ‘primary’ cross girders. They capture some of the load applied to the secondary cross girders, which sit on packers on steel stringers framing into the primary cross girders (Figure B7).
